ECOLOGICAL MANAGEMENT PLAN

STAGE 2 – Lot 9

Prepared for **Blue Care**

**Grasstree Court
Sunrise Beach, Qld, 4567
Lot 9 SP322789**

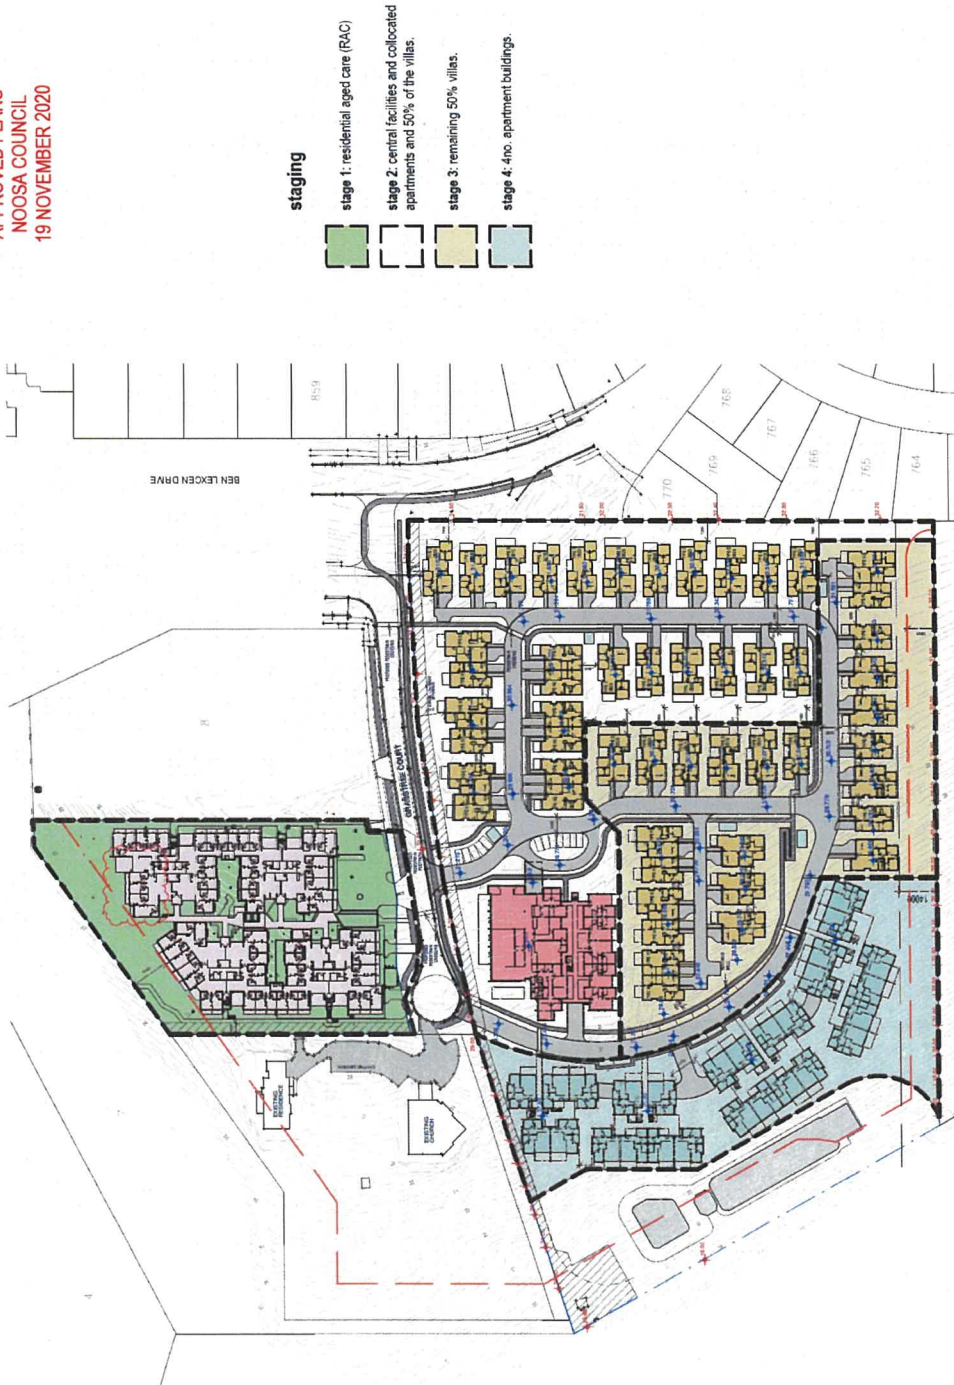
Figure 2 – Approved Staged Development

staging

- stage 1: residential aged care (RAC)
- stage 2: central facilities and collocated apartments and 50% of the villas.
- stage 3: remaining 50% villas.
- stage 4: 4no. apartment buildings.

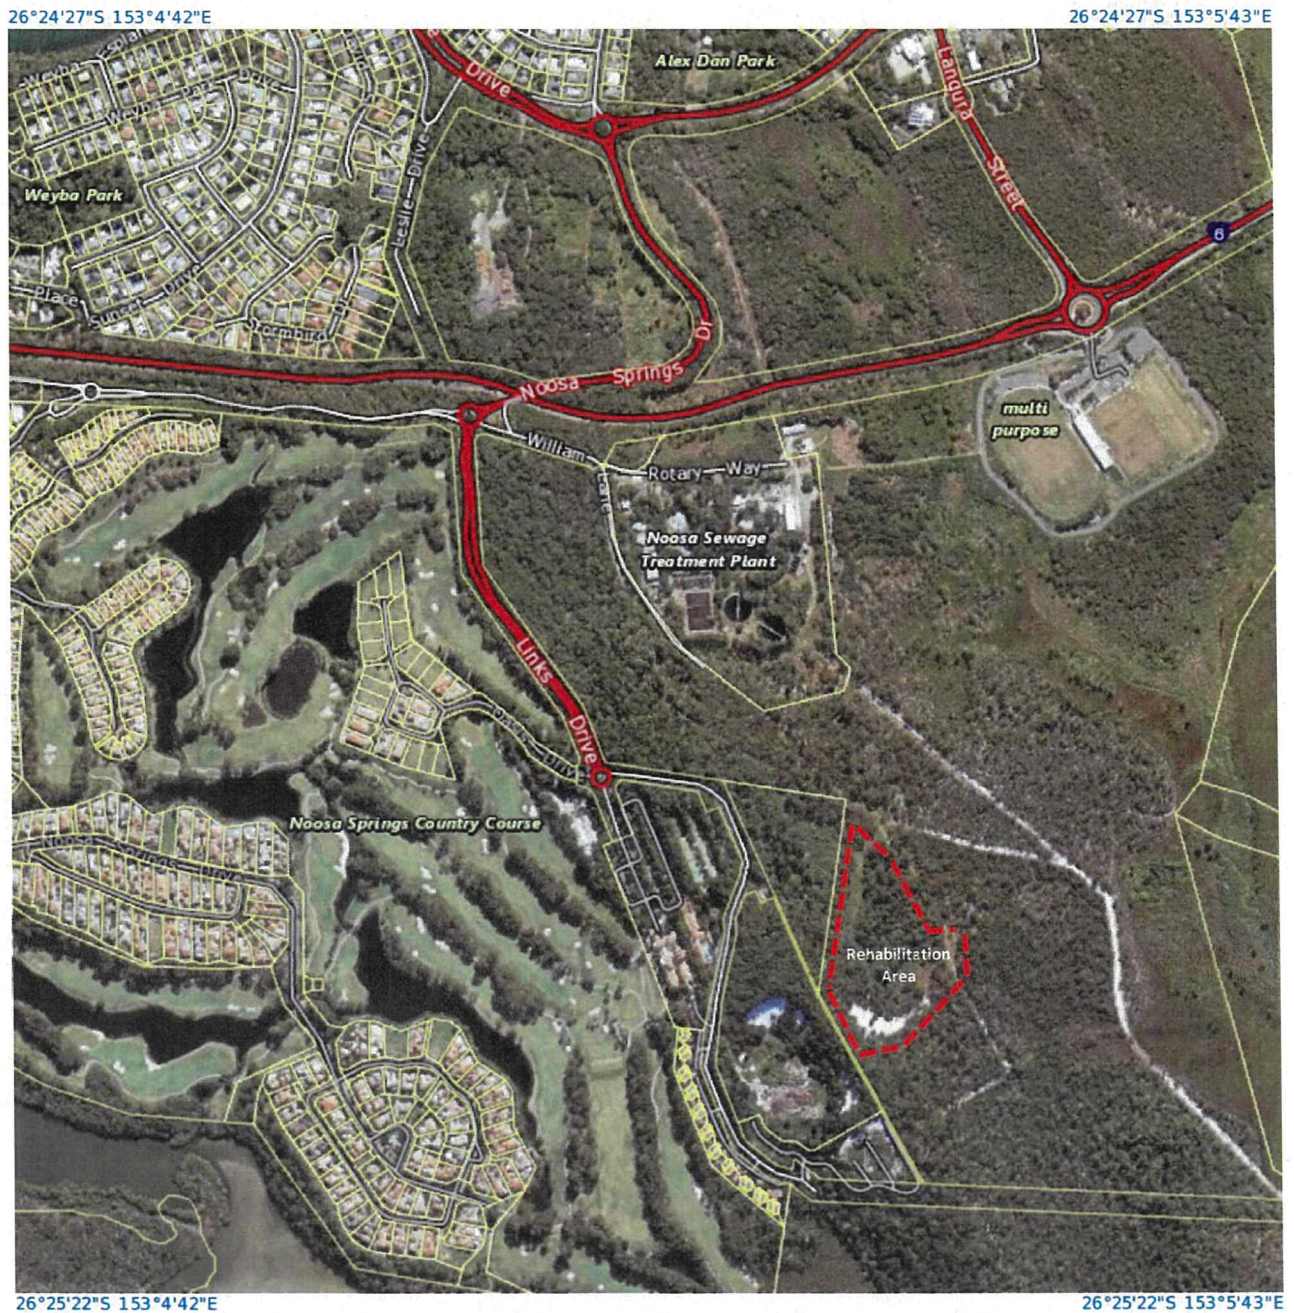
FIGURE B1A – Receiving/Rehabilitation Site Locality 2018

Rehabilitation Area (red dashed line approximate only) - Source: QLD Globe 2018

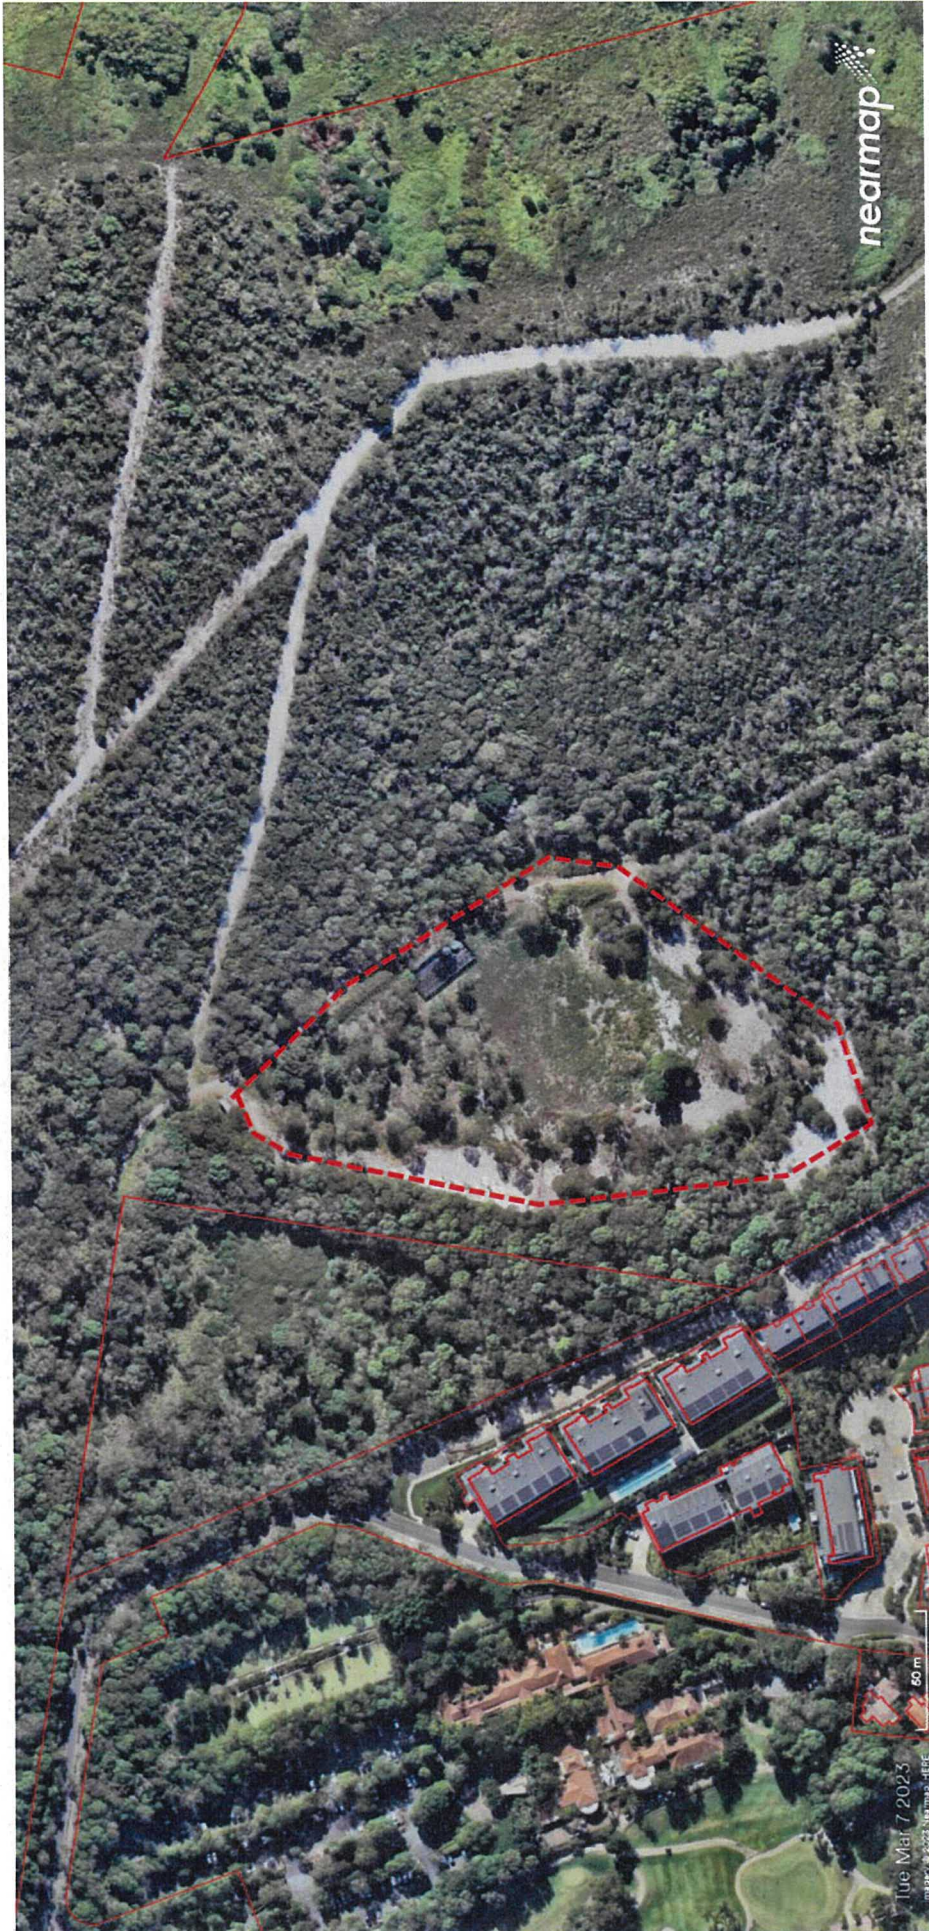
FIGURE B1B – Receiving/Rehabilitation Site 2023

Rehabilitation Area (*red dashed line* approximate only) - Source: Nearmap Aerial March 2023

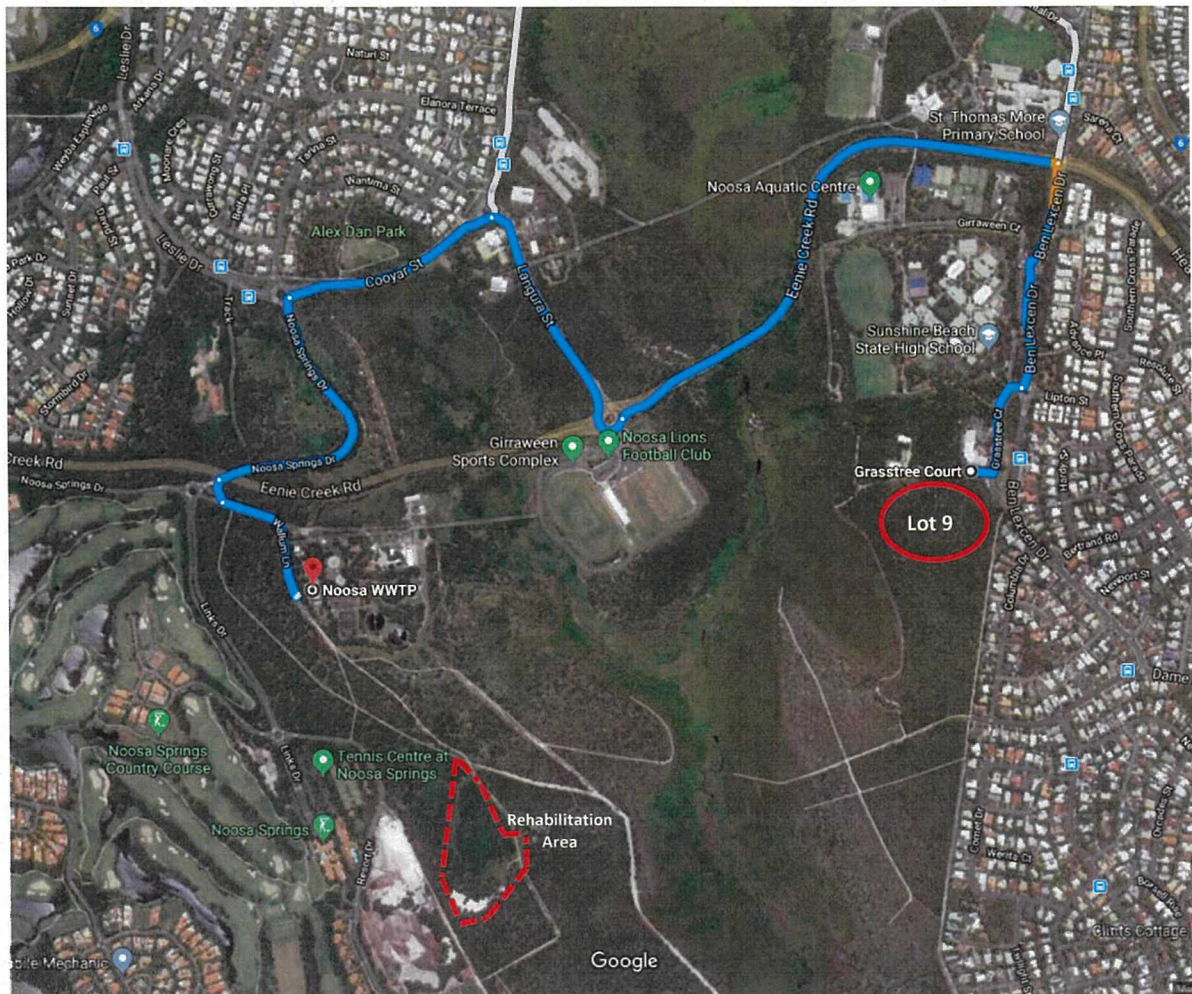
FIGURE B3 – Public Road - Transport Route *(shaded blue)*

Subject Land (Lot 9 Development Site) to Rehabilitation (Receiver) Site *(red hatching)*

Material will be transported to the receiver site via the existing roadway network. The shortest route is approximately seven minutes on public roads, pending traffic conditions (refer **FIGURE B3 – Transport Route**). Transportation of material will occur in accordance with any specific traffic management plans, however, would aim to occur outside of peak traffic periods.

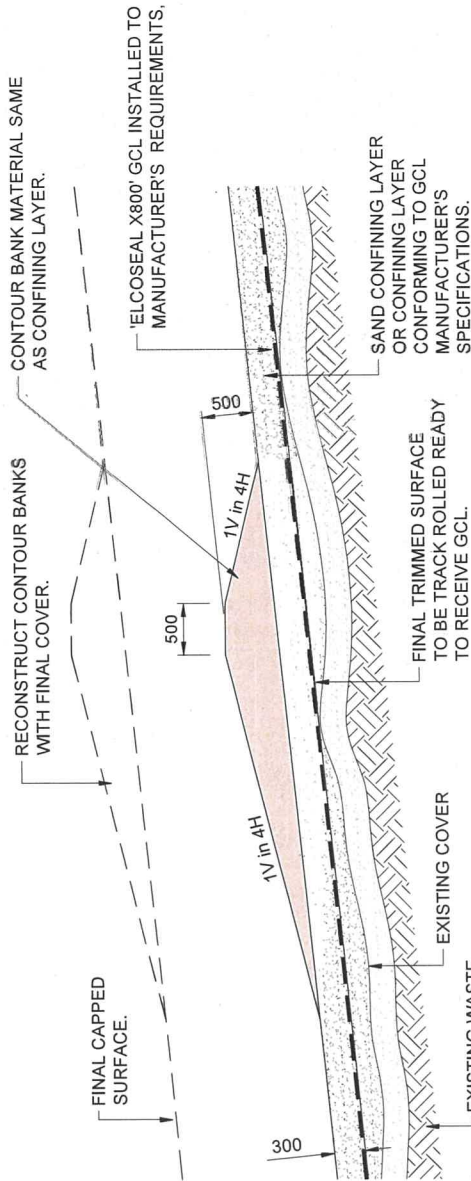
CONTOUR BANK (TYPICAL SECTION) EXISTING SURFACE SLOPE 1 in 10

NOTE: IF TIME FOR COMPLETION OF FINAL COVER IS GREATER THAN 6 MONTHS THEN CONSTRUCT THE CONTOUR BANKS TO DETAIL WITH A LOGITUDINAL FALL OF 1 in 100.

RECONSTRUCT CONTOUR BANKS WITH FINAL COVER.

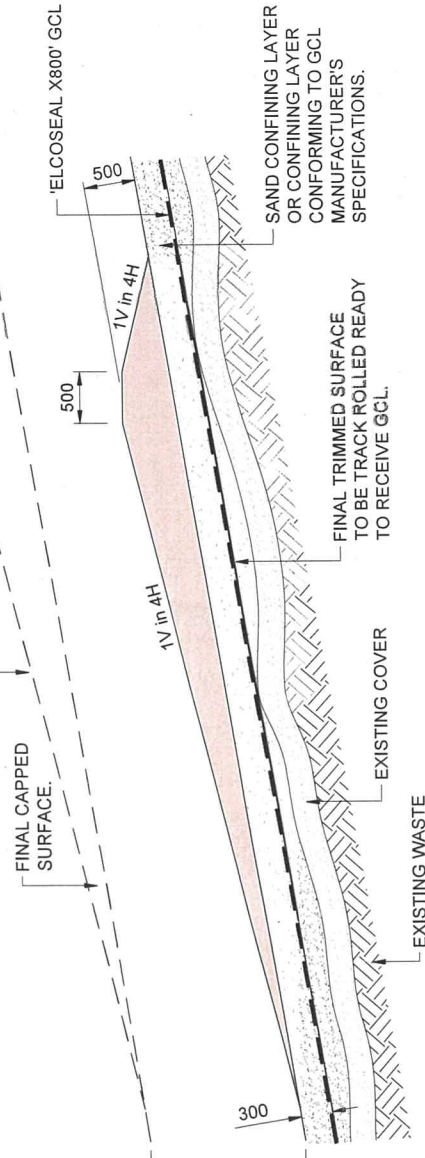
CONTOUR BANK (TYPICAL SECTION) EXISTING SURFACE SLOPE 1 in 6

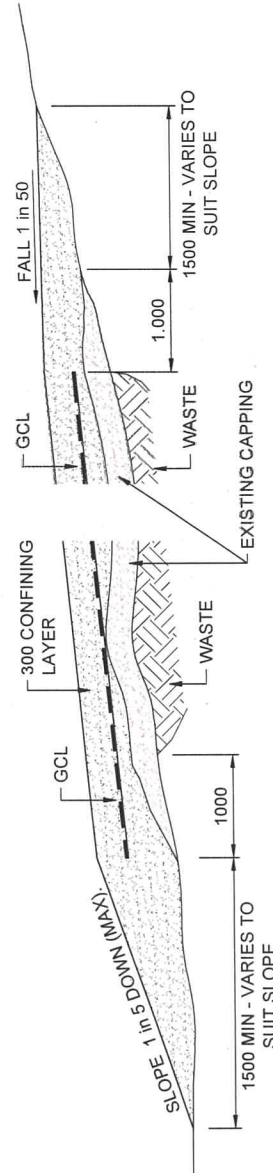
CONFINING LAYER TAPER SECTIONS DOWNSLOPE & UPSLOPE
